# Fort Wayne Performing Arts Center

\* Arches...and efflorescence

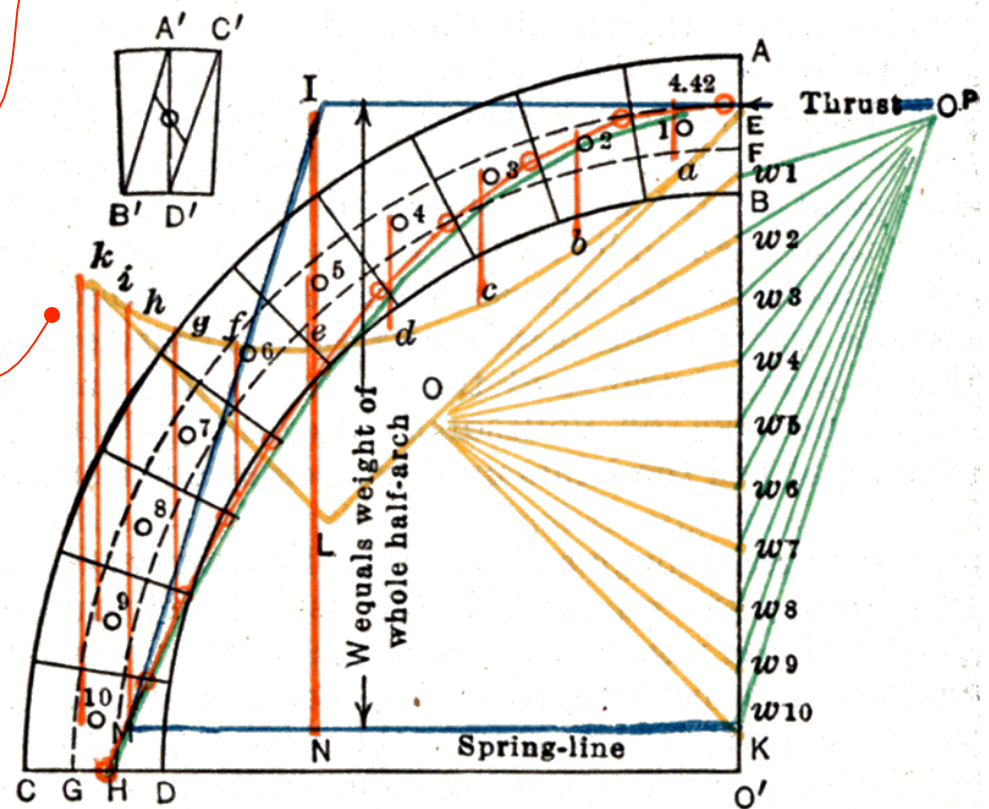
Method of finding center of gravity of voussoir

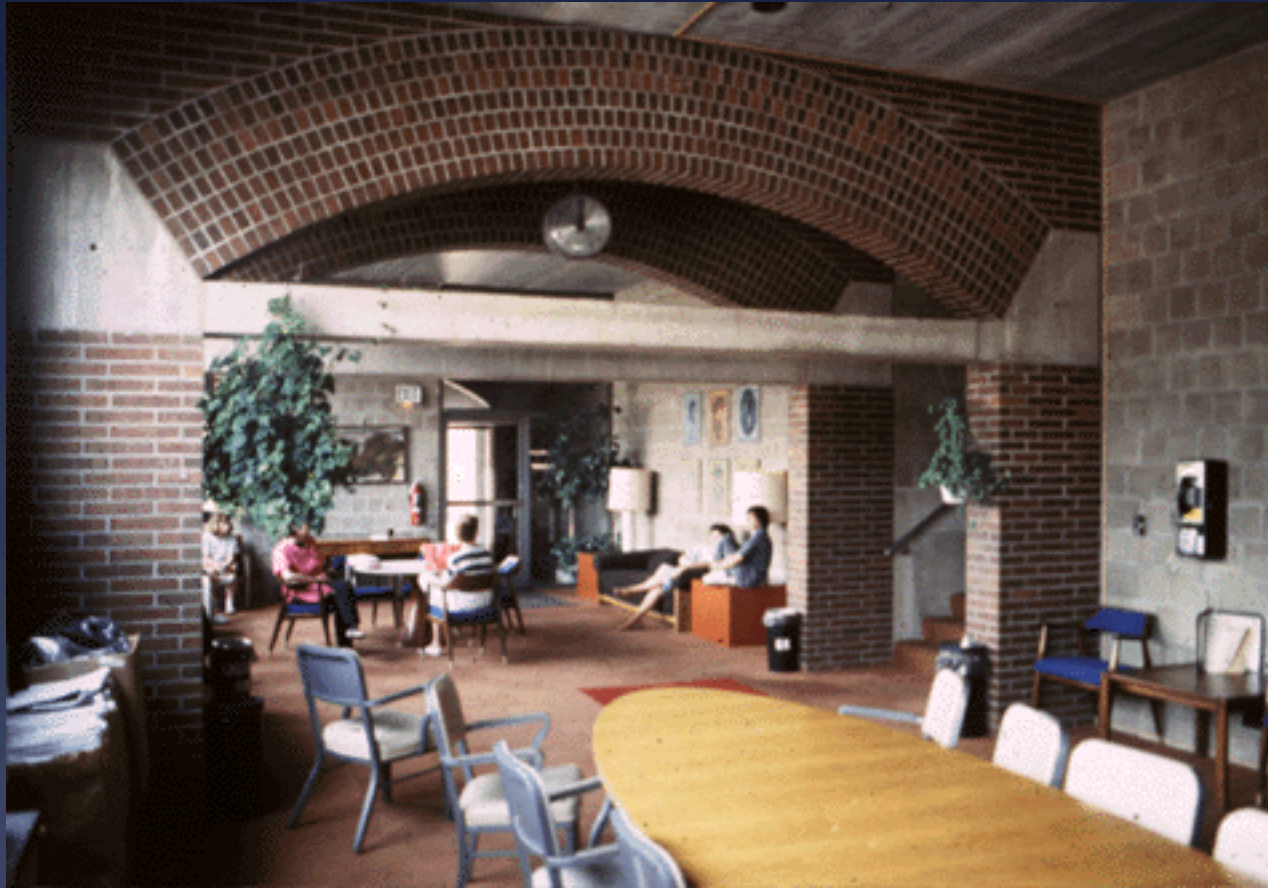
This 7 rowlock deep segmented arch is tied with a concrete tension member to minimize lateral thrust on the adjacent walls.

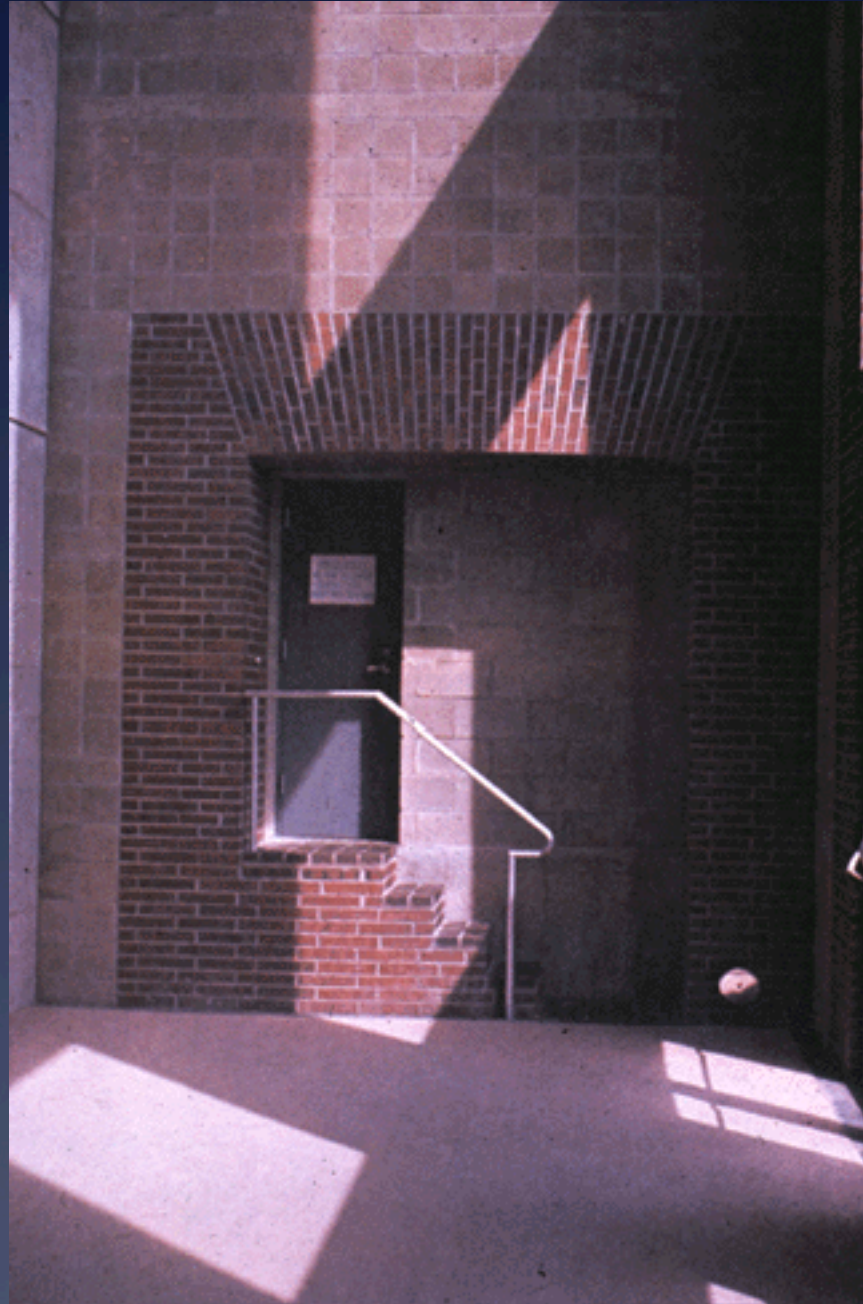
This flat or jack arch and brick masonry surround marks the actors entry to backstage.

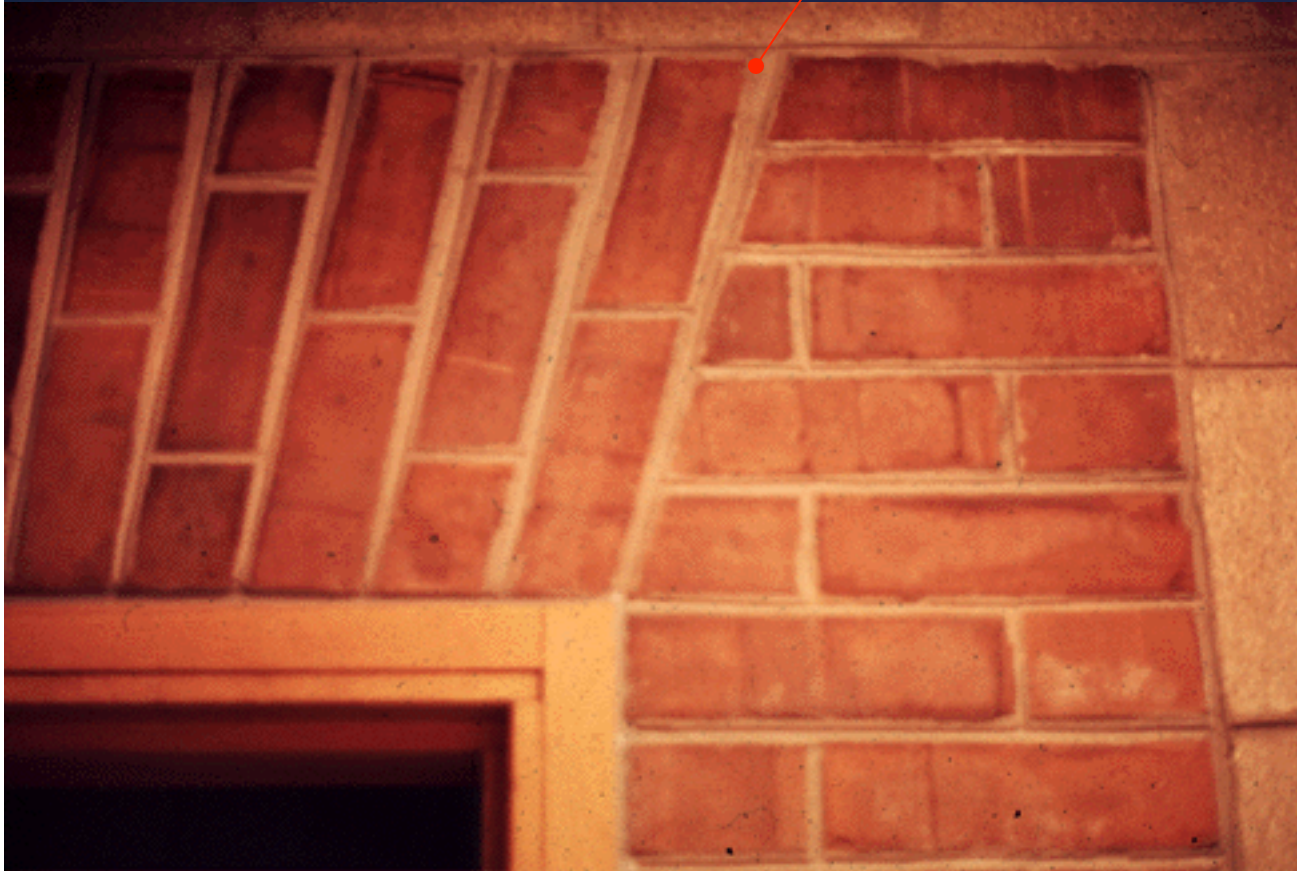
• Triangular joints a  
“rough” arch  
If the bricks were  
triangular and the  
mortar joints  
rectangular, this  
would be a  
“gauged” arch...a  
more refined arch

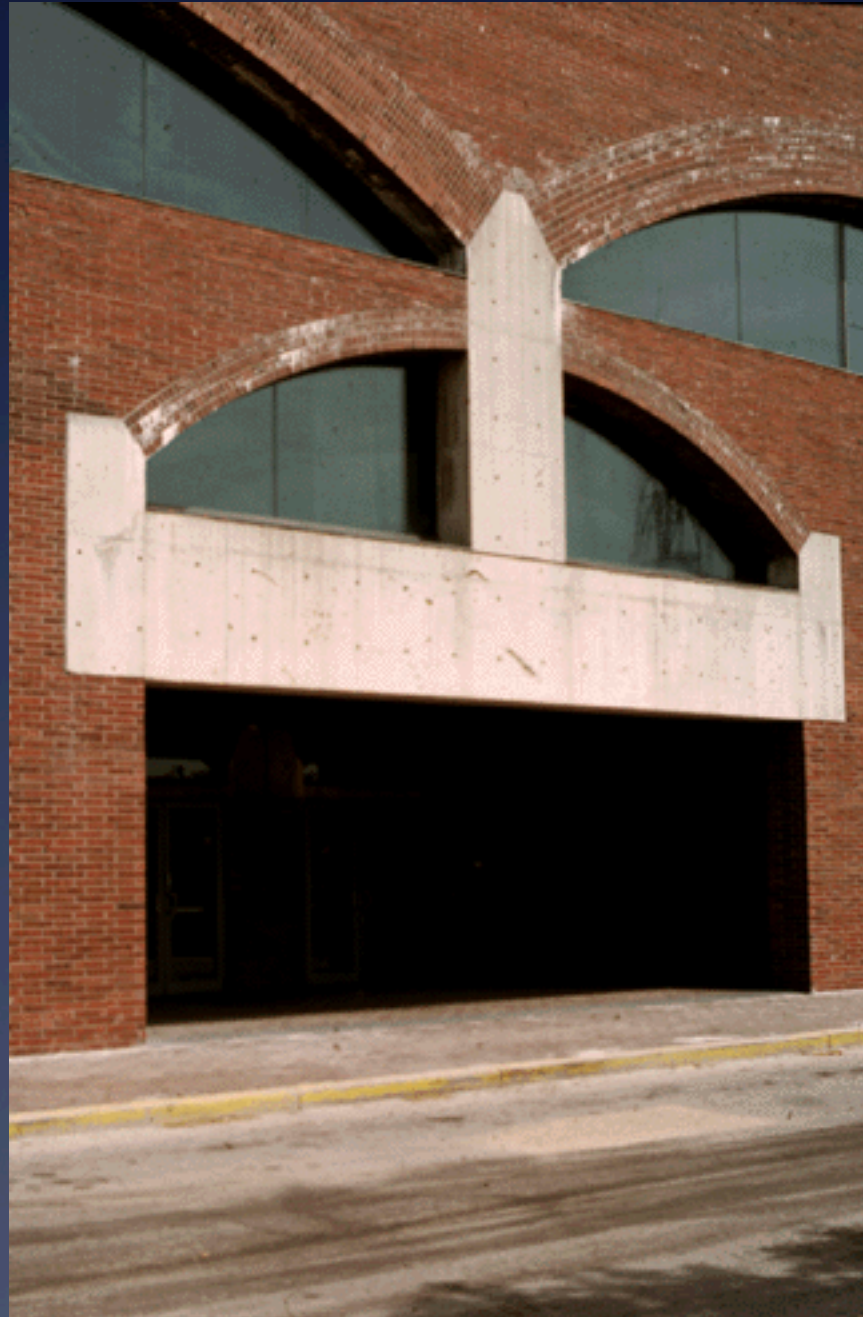
The white powder on the surface at the arches is efflorescence - salts dissolved out of the brick and mortar, which moved down the wall (following gravity) until the salt water hit an interruption in the wall (the arch.) The water soaked in the arch, evaporated through the arch face, leaving the salt deposits behind

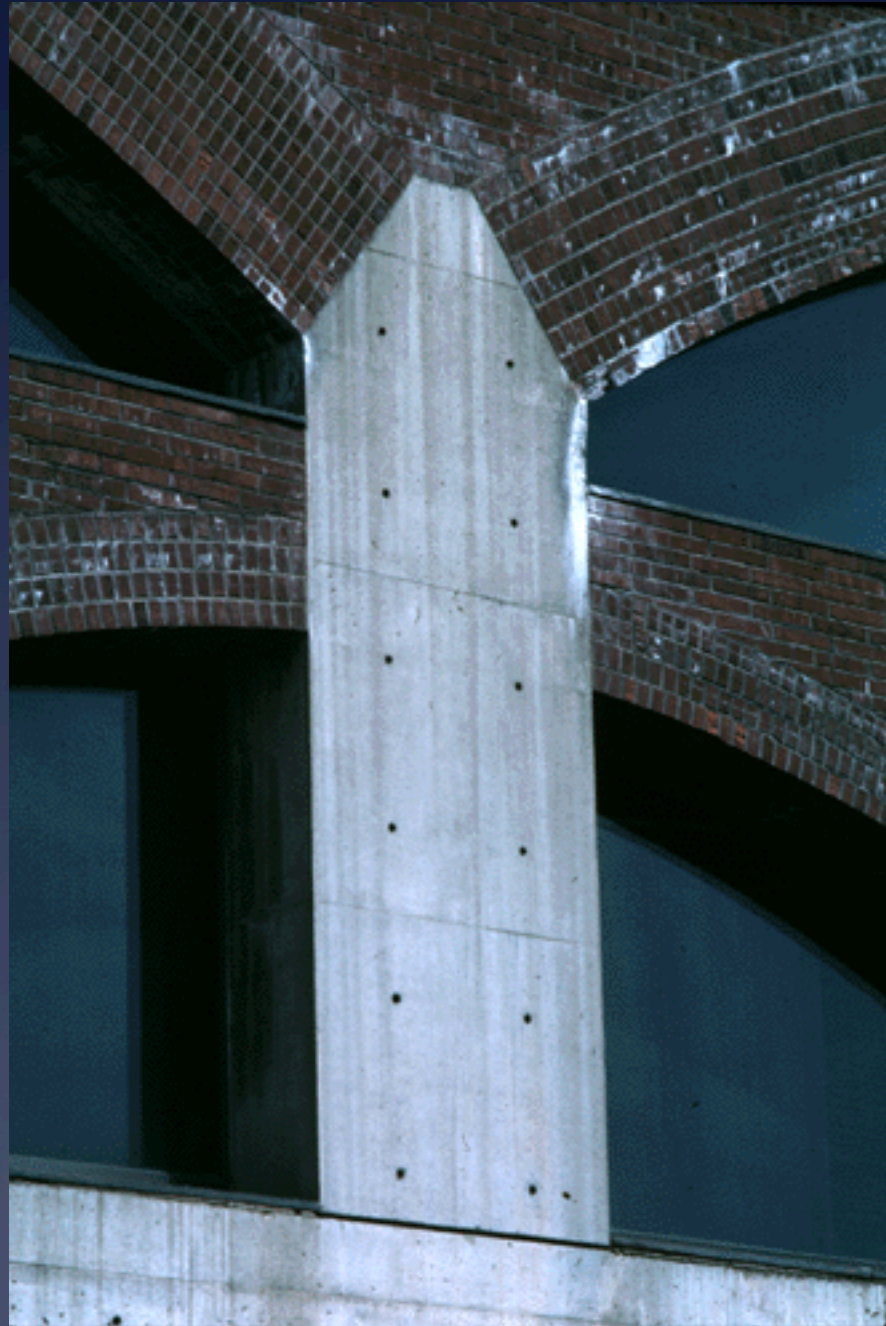
Usually, efflorescence is a sign of a leak.

The leak is usually in a joint or material change above where the salt is found

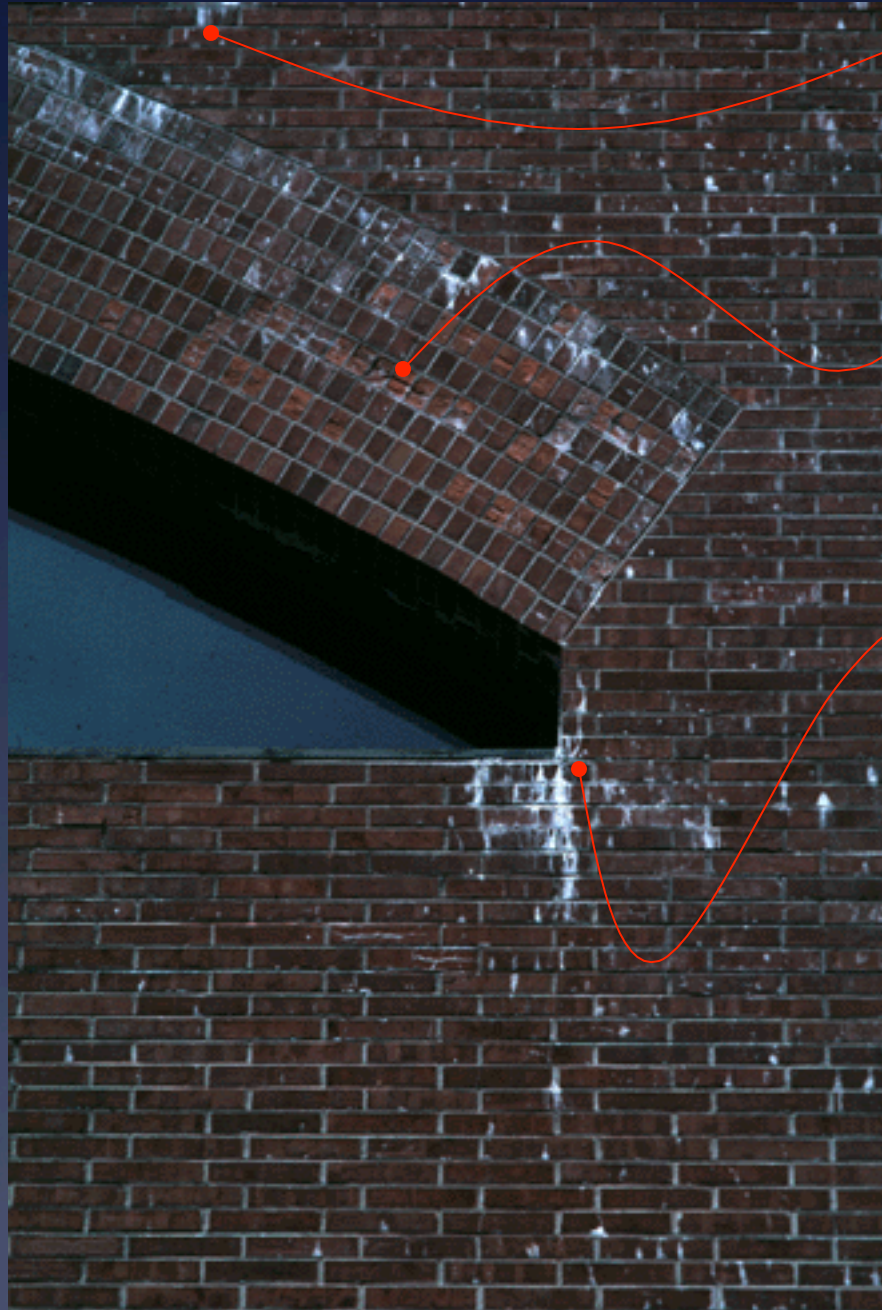
• Water leaking from parapet coping above.

• Soaked bricks froze and the faces spalled off.

• No end dam at the flashing under this slate sill.

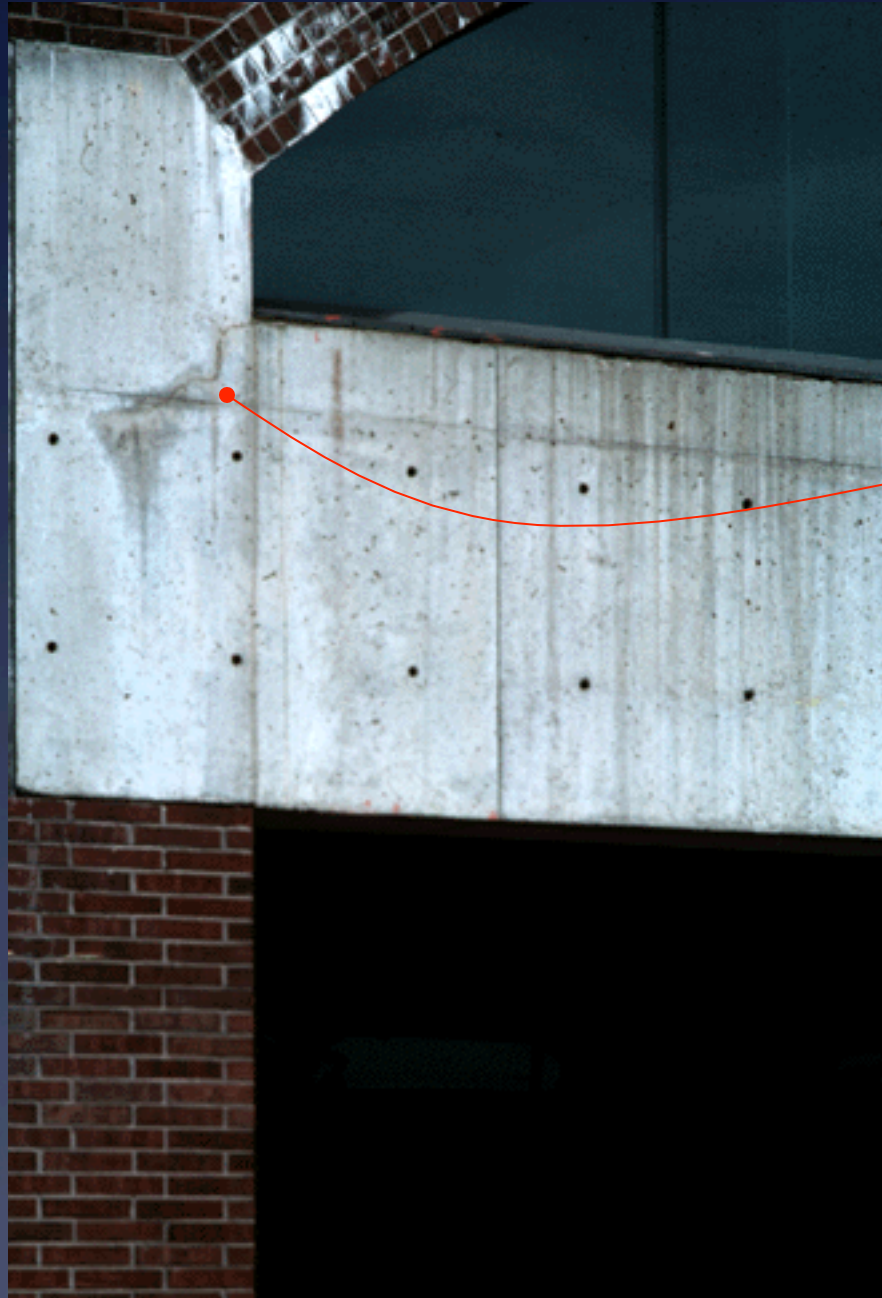
Water can even destroy large concrete elements.

Here, the lack of an end dam for the sill flashing has loaded the concrete with water, contributing to the crack.

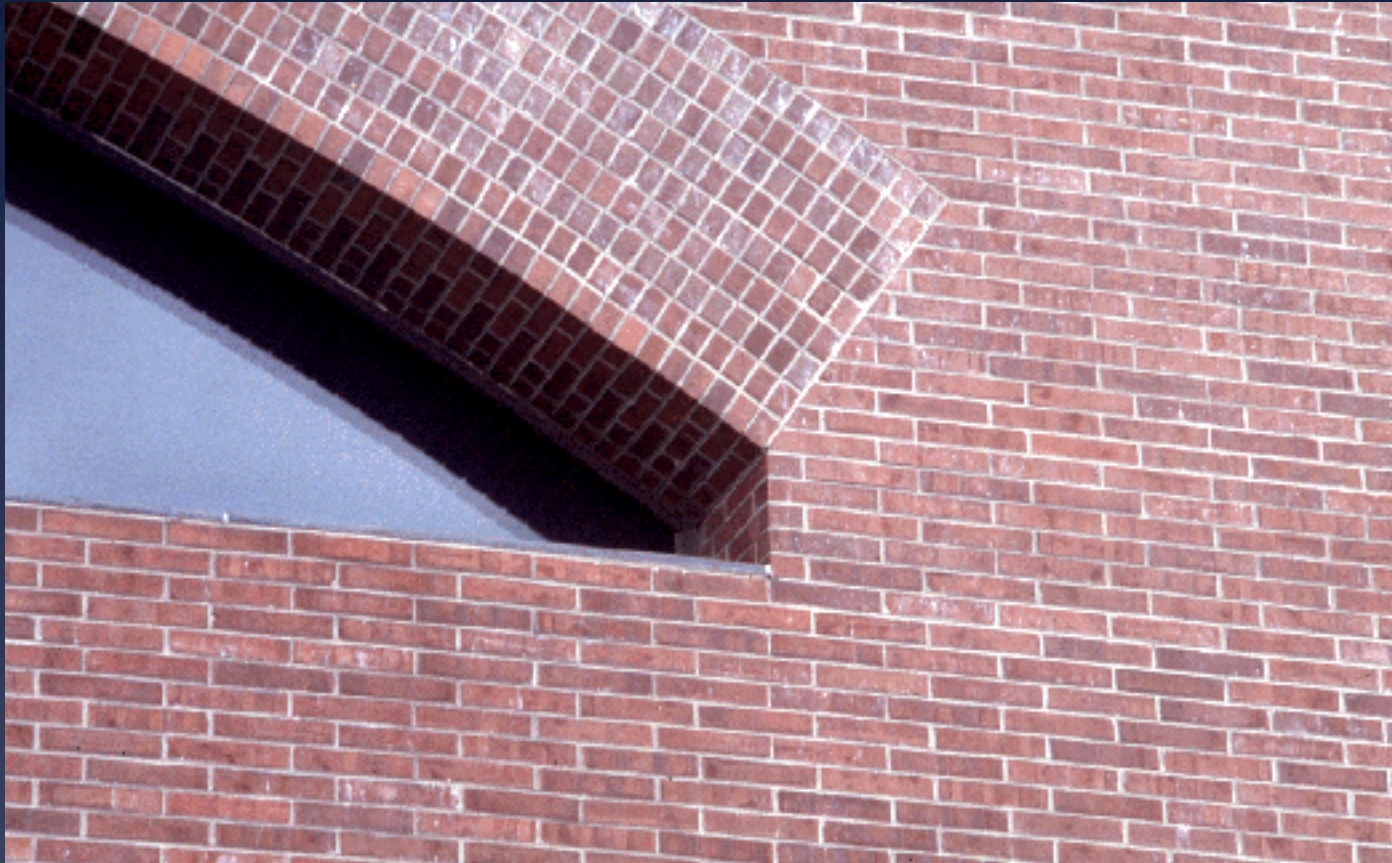
Years later, the arch was dis-assembled by removing and replacing alternating bricks (similar to underpinning.) As is often the case, finding matching bricks was almost impossible. The flashing was installed correctly and it looks like no leaks!

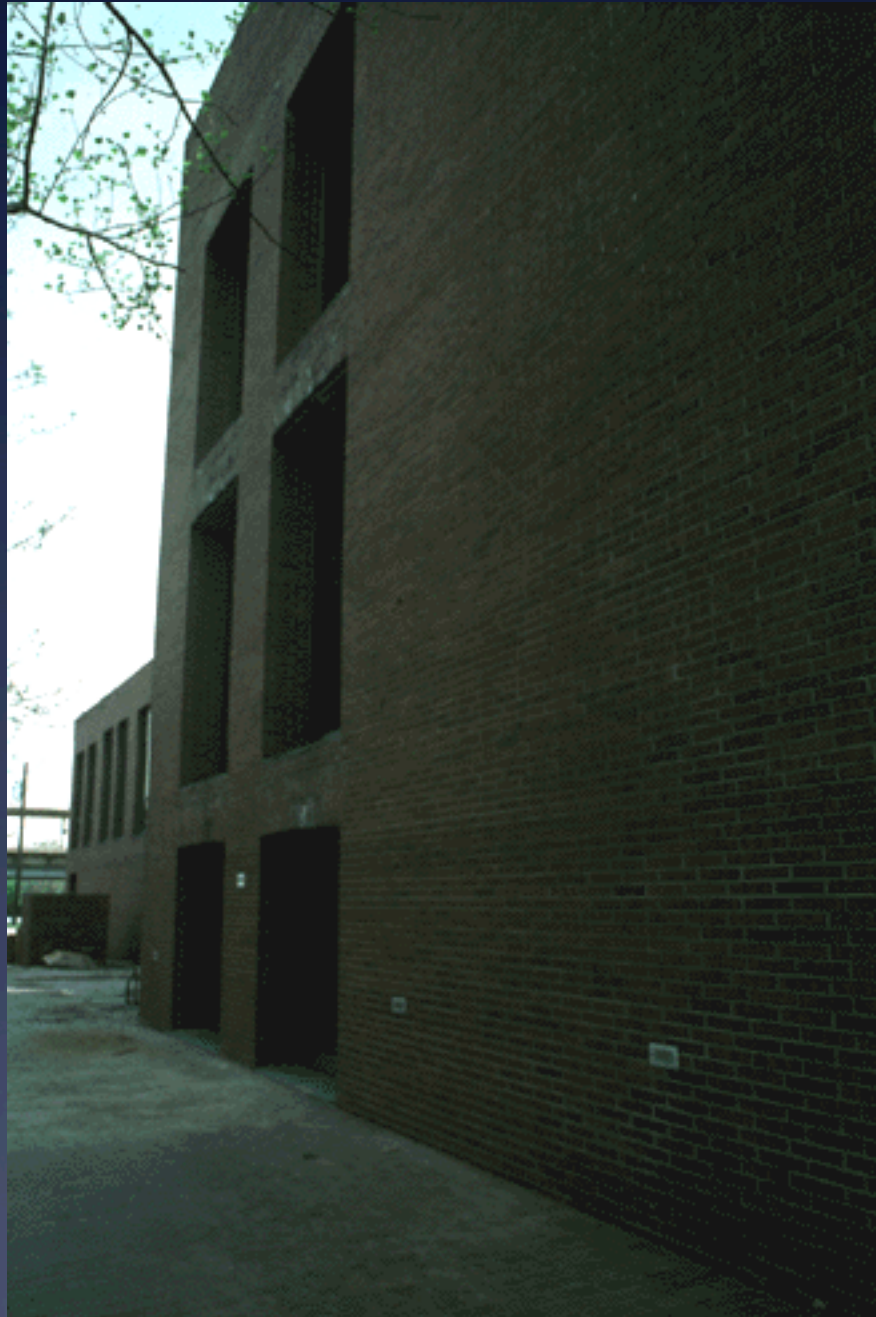
Setting the windows at the back edge of the wall instead of over the cavity increases the presence of the walls mass.

This requires that sill flashing and material be of the highest quality as it leaves a deep, low sloped sill to catch water and snow.

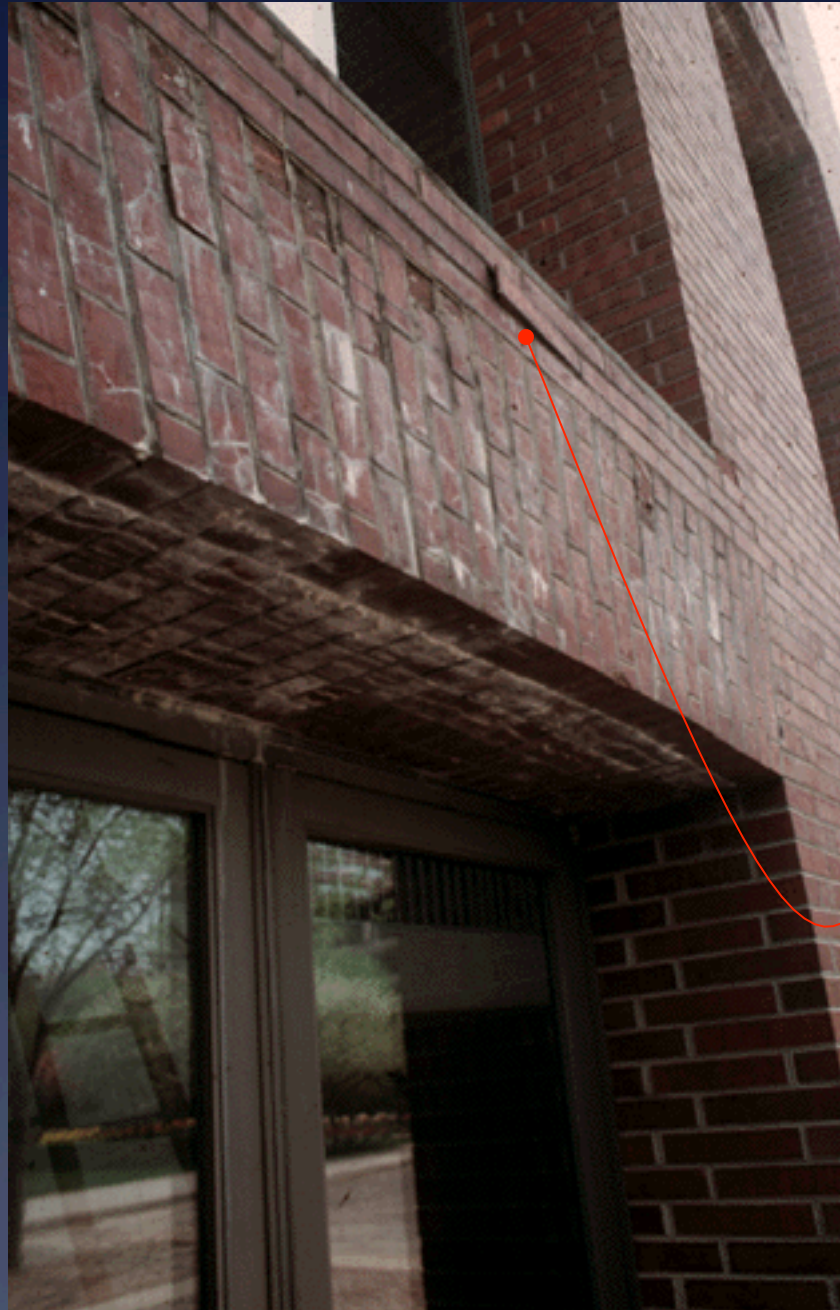
If not repair quickly the leaks fill the masonry with water. The freezing and thawing of winter and spring can blow the face off the brick

Go to the deteriorated location and look up to find the leak

Slight rise on  
the bottom of  
the arch  $1/8''$   
per foot of  
span

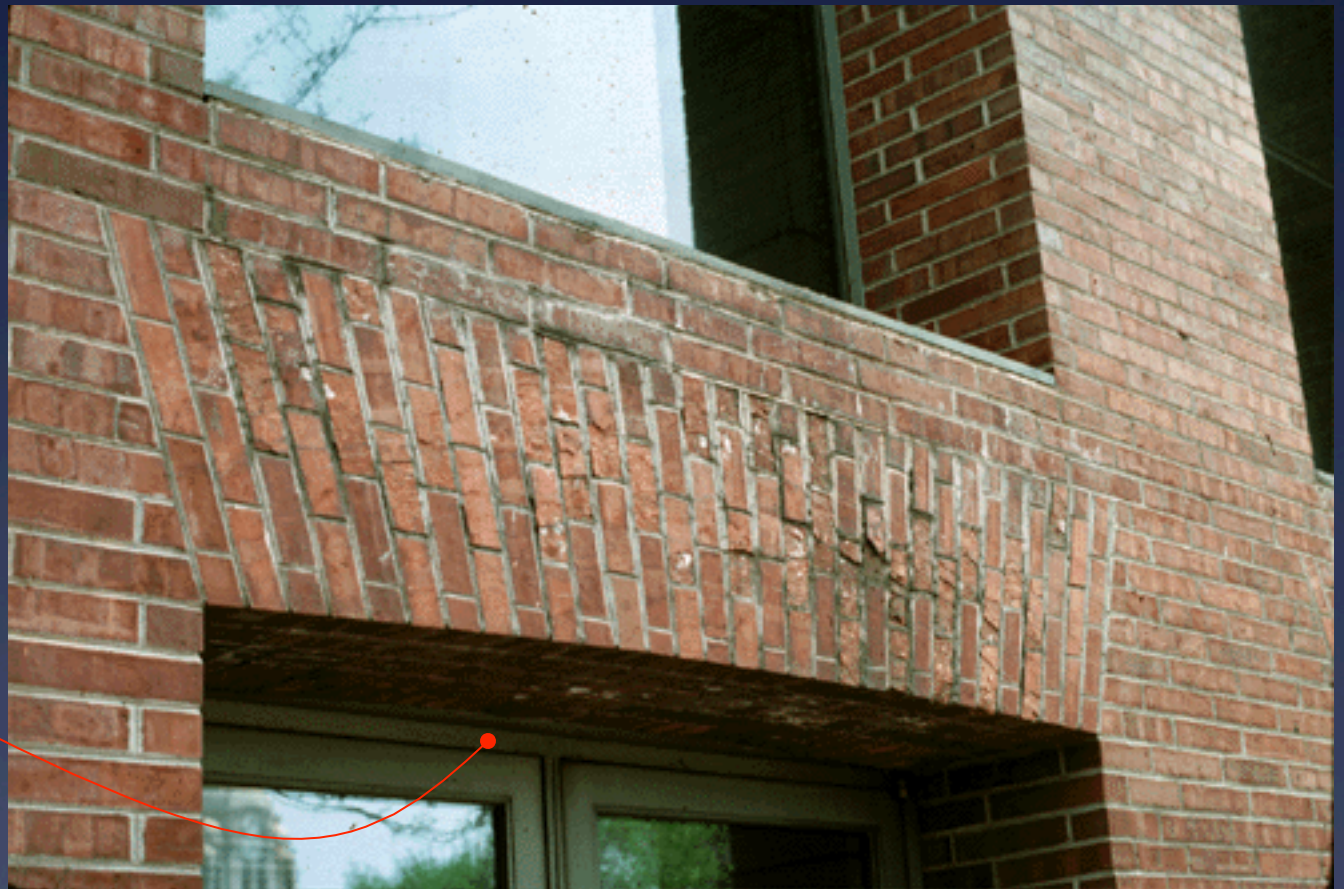
The deterioration is mostly cosmetic, but because these arches bear load, the weakening brick has to be replaced.

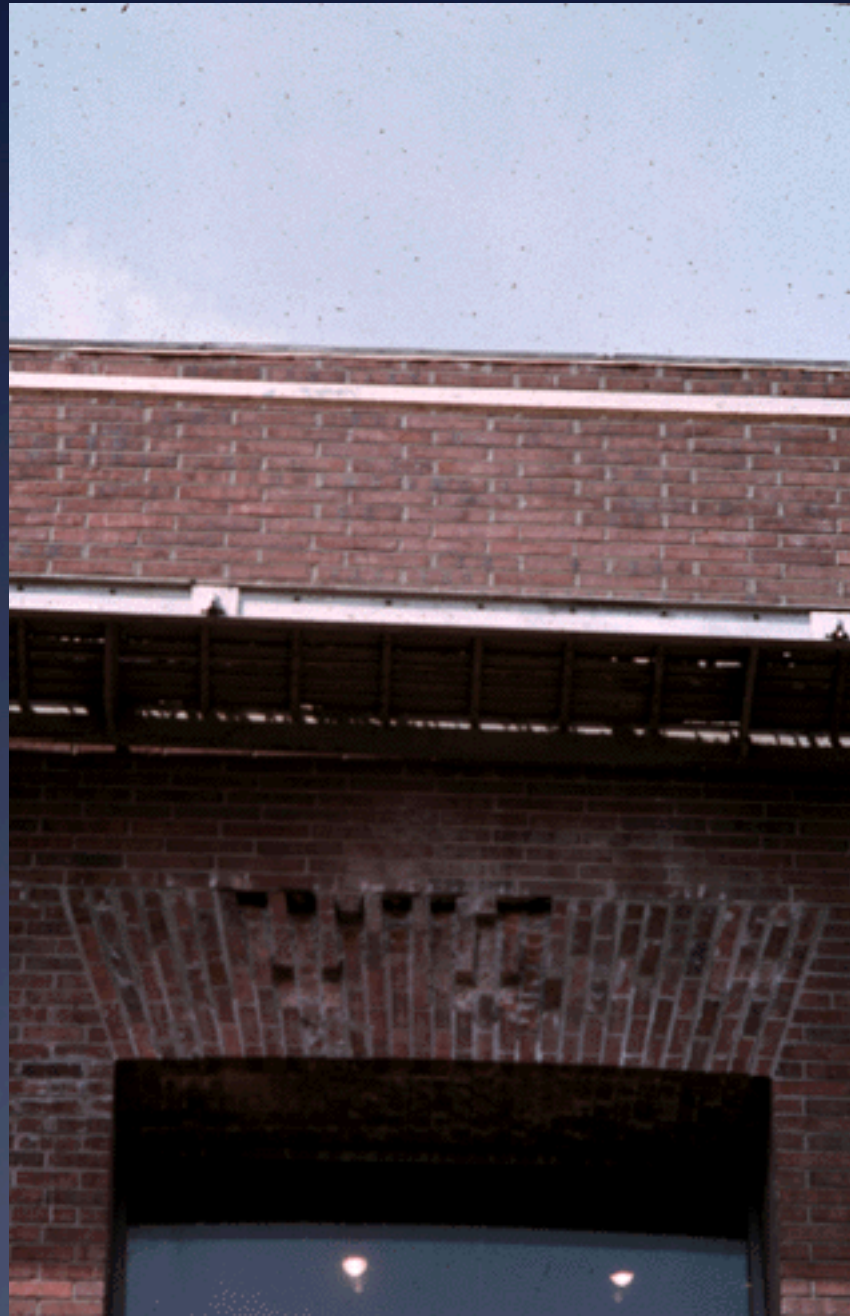
The slate coping at the parapet has been removed, new flashing installed below the coping and the slate replaced.

The bricks in the arch have to be cut out one at a time and new brick toothed in.

Skewback 1/2"  
per foot of  
span per 4" of  
arch depth

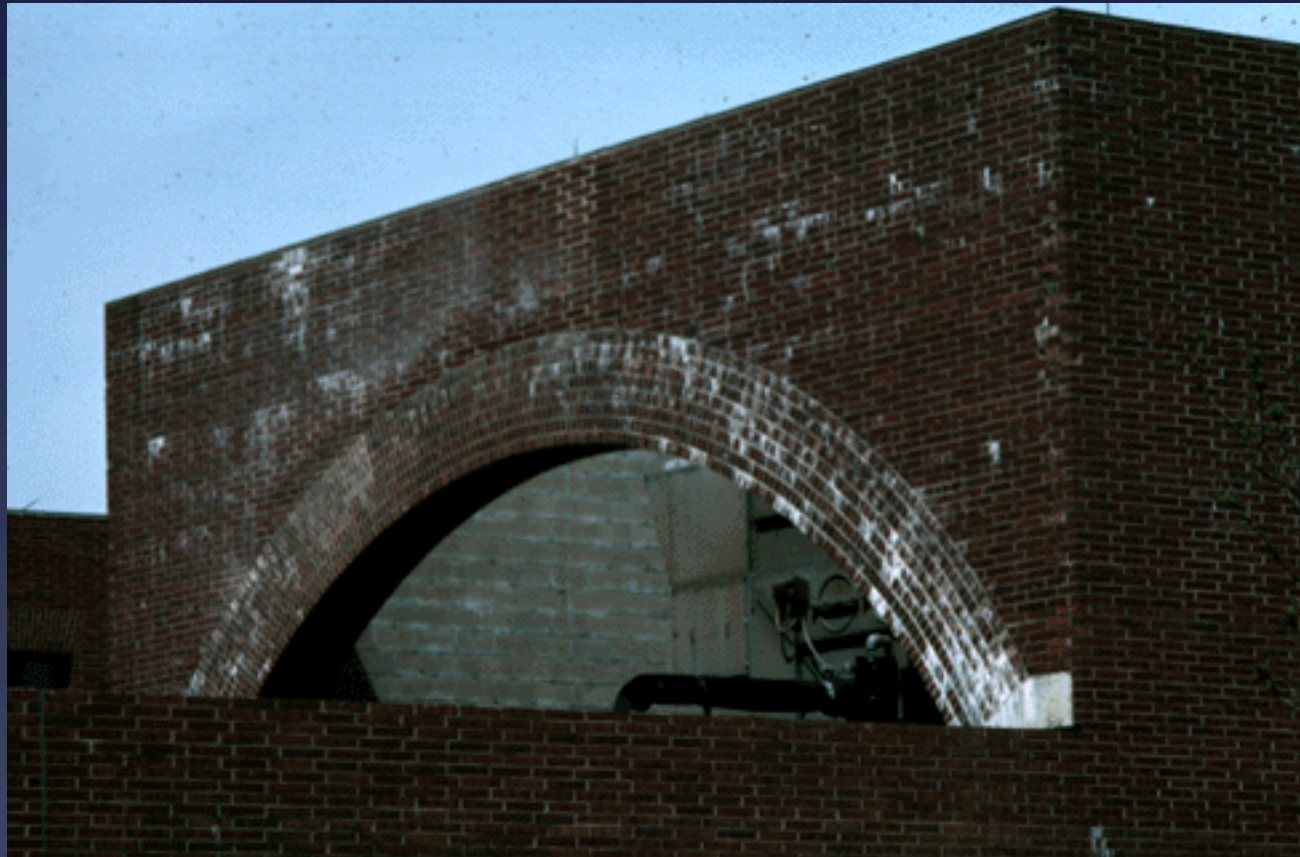
The worst case for the masonry was where it was exposed to moisture from both sides. What does the cooling tower behind this arch produce? How often?

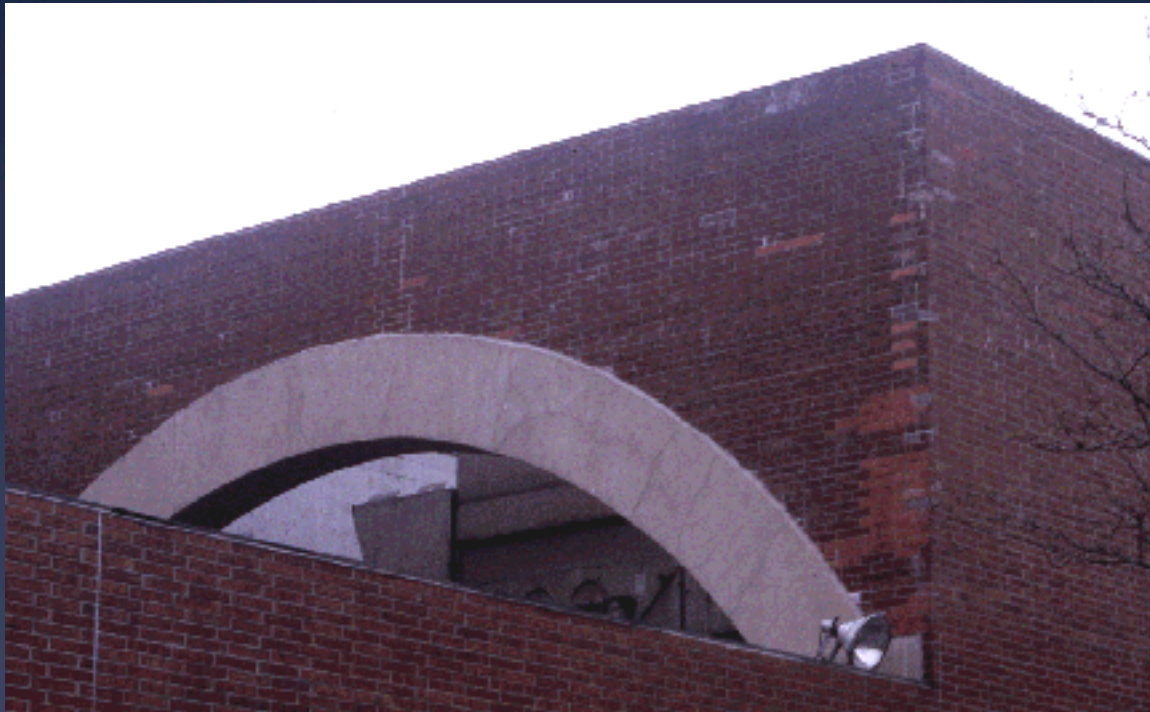
This arch was deemed too badly damaged, and out of sight so it was covered up with cement stucco. How is the stucco doing?

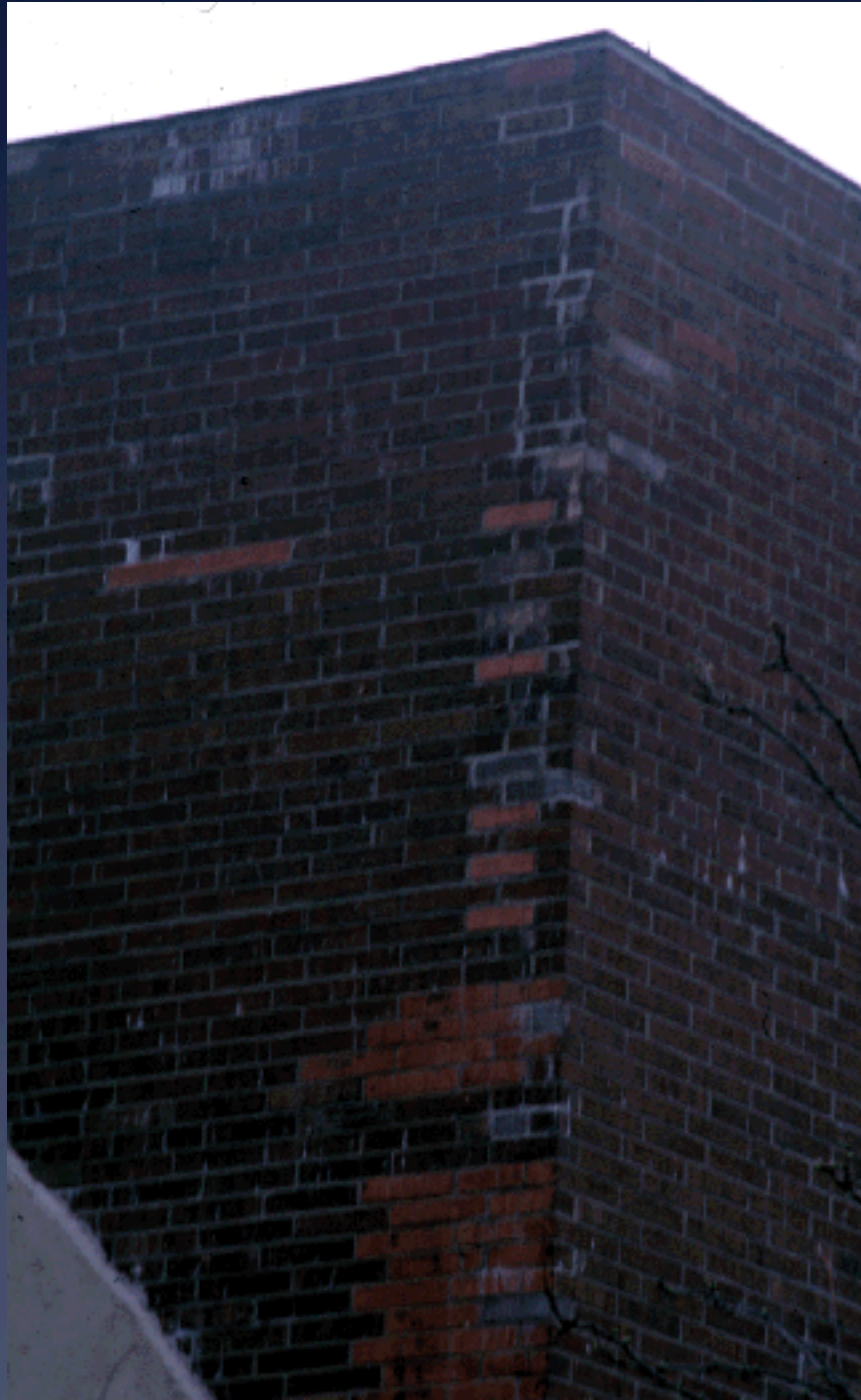
The corners of the cooling tower enclosure were patched with some not-very-close-to-matching brick....

Or bondo, or patching compound.

Damage like this is pretty hard to repair to original condition.

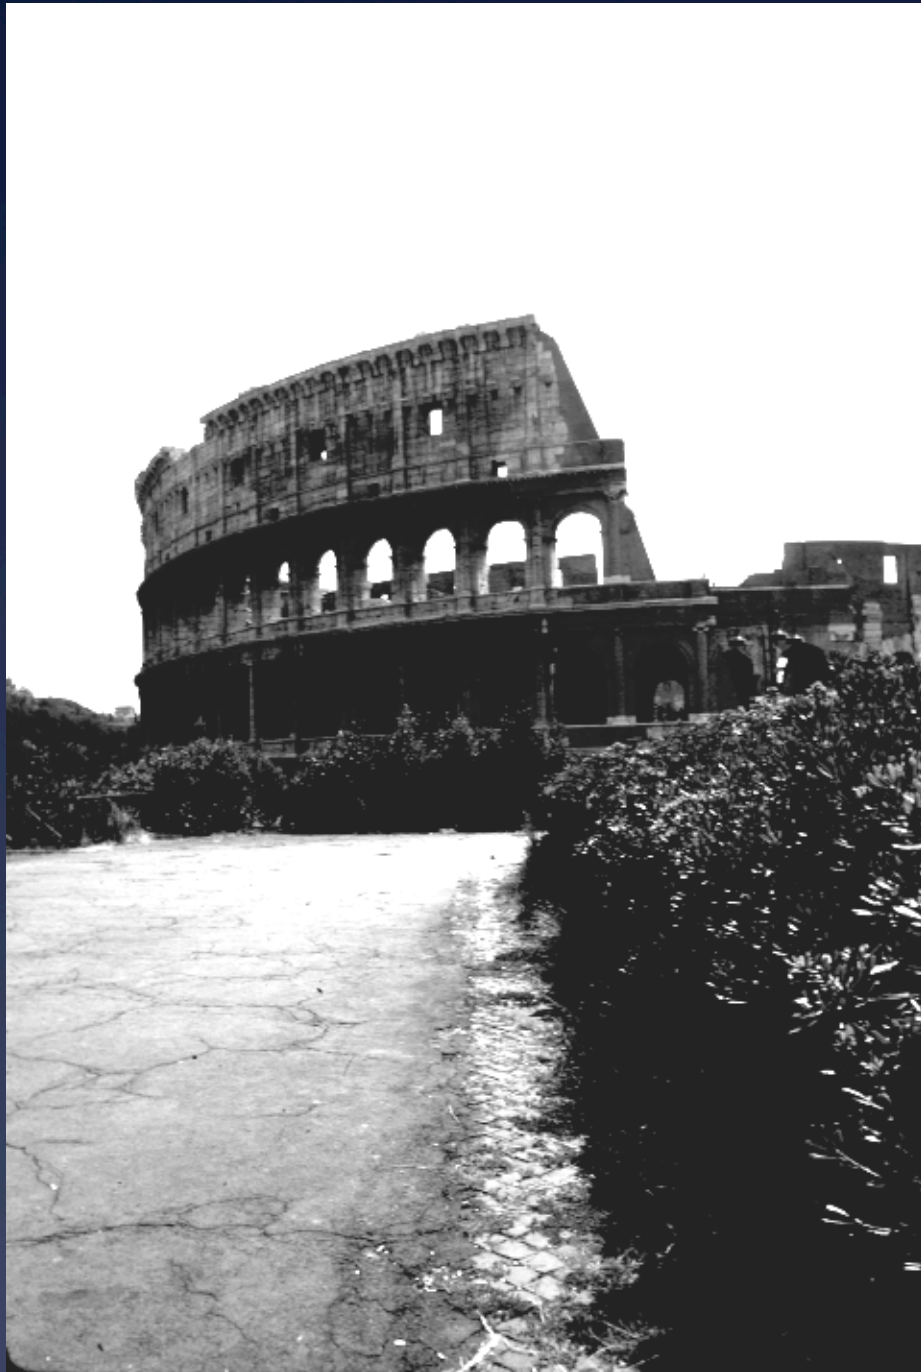
When the empire was rapidly expanding, material and skilled labor shortages were common.

To work around these shortages, the Romans developed new construction methods and materials.

Primary among these was the composite wall. A wall with layers tasked to cladding, formwork, and structure

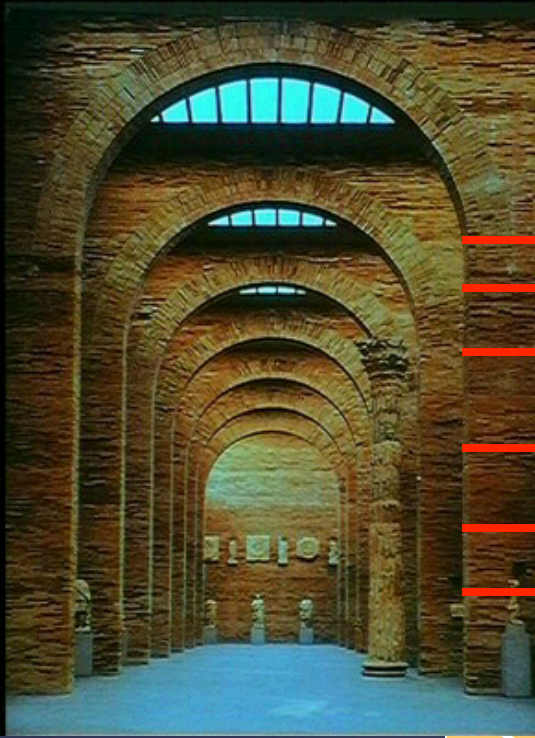
Moneo uses the brick as formwork for a concrete fill, very similar to the Roman methods
